Effects of Ground Failure on Bridges, Roads, and Railroads

The long duration and strong velocity content of the motions produced by the 27 February 2010 Maule earthquake resulted in widespread liquefaction and lateral spreading in several urban and other regions of Chile. In particular, critical lifeline structures such as bridges, roadway embankments, and railroads were damaged by ground shaking and ground failure. This paper describes the effects that ground failure had on a number of bridges, roadway embankments, and railroads during this major earthquake. [DOI: 10.1193/1.4000024]

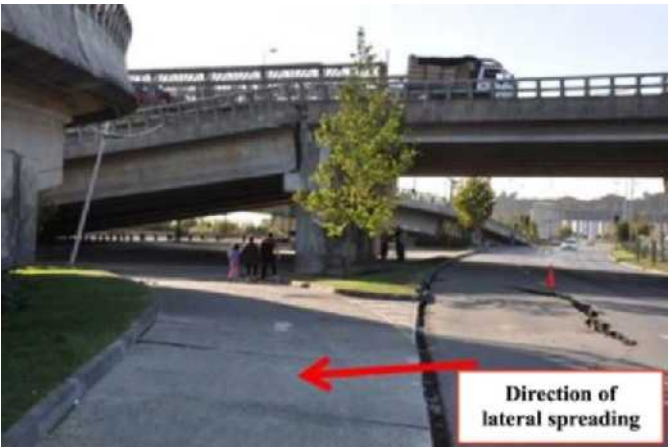
lane of Calle Nueva road and continuing hundreds of meters northward and southward along a pedestrian walkway (Figure 5). Calle Nueva parallels the riverbank and runs under the bridge approach. Lateral spreading toward the river caused sufficient displacement to unseat the west and eastbound bridge deck (Figure 4). Closely spaced (0.1 m

Figure 4. Deck unseating at Llacolén Bridge in Concepción. Cracking resulting from lateral spreading is visible on right side of photo. View north ($S36.830380^{\circ}$ $W73.067541^{\circ}$).

to 0.2 m on center) flexural cracks on the riverside face of the 1.5 m diameter support columns were observed near the ground surface. The distribution of flexural cracking was more severe for those columns supporting the unseated deck; however, all columns at the north riverbank support experienced flexural cracking at their construction joint

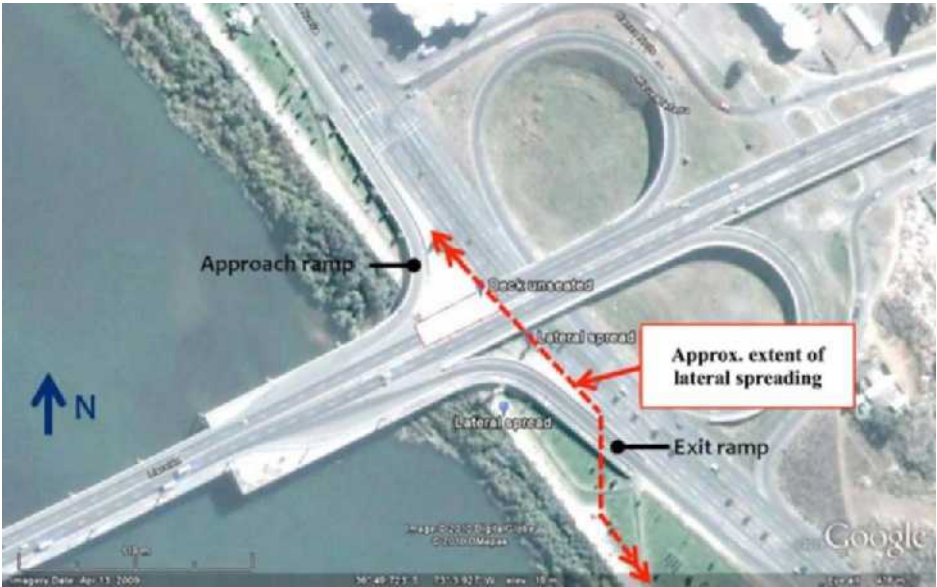
Figure 5. Plan view of the north approach to the damaged Llacolén Bridge in Concepción ($S36.830108^{\circ}$ $W73.067991^{\circ}$).

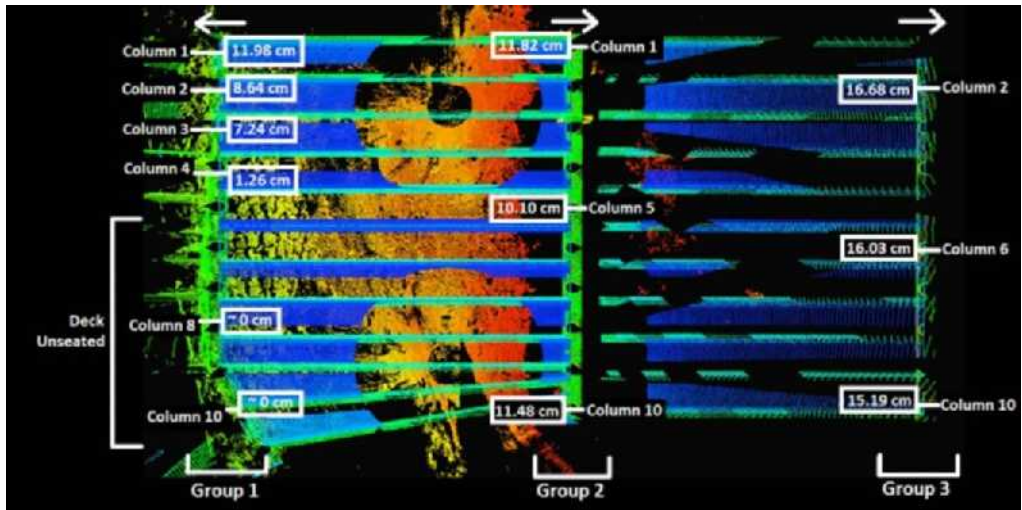
Figure 6. LIDAR measurements at the north end of Llacolén Bridge: Relative horizontal displacement of the columns with respect to their bases.

(between 2 m and 2.5 m above ground surface). Ground settlement of 0.25 m to 0.30 m also occurred at each of the exit ramp bents. According to [FHWA \(2011\)](#), the nearby ground settled up to 0.4 m and experienced significant shaking, resulting in a 0.25 m separation between the columns and the surrounding ground. Terrestrial LIDAR measurements, performed after the earthquake ([Kayen 2012](#)), show that the relative horizontal displacement of the columns with respect to their bases varied from 0 cm and 12 cm away from the river at the columns in the shoreline support, while the second and third rows of columns experienced a rather uniform displacement of their upper ends of 11 cm and 16 cm, respectively, toward the river (Figure 6).

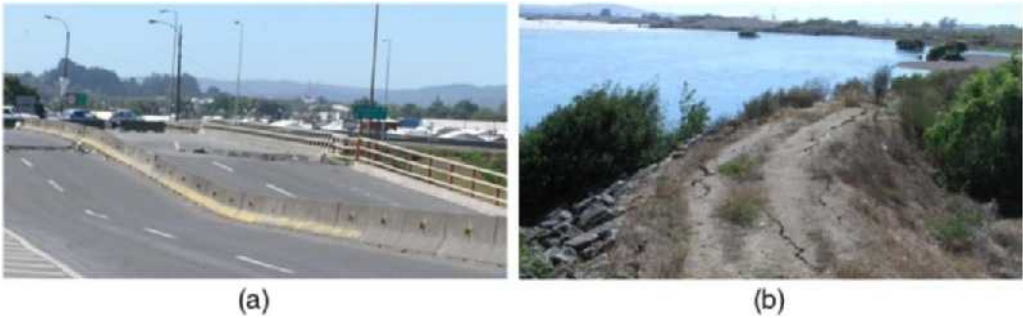
During the earthquake, the bridge suffered severe damage and was closed to the public. Liquefaction and lateral spreading at the northeast approach resulted in significant damage to the bridge superstructure (Figure 9). Most notably, liquefaction caused large settlements at several support piers and lateral displacement of the bridge deck. Visual inspection of the surrounding soils indicated the presence of fine loose sands. Several sand boil deposits with

Figure 9. Juan Pablo II northeast approach: (a) Settlement of bridge deck near bridge approach (view East, S36.815900° W73.084064°); (b) lateral spreading of northeast approach embankment.

diameters in the order of 1 to 10 meters were observed near the structure on both sides of the approach embankment.

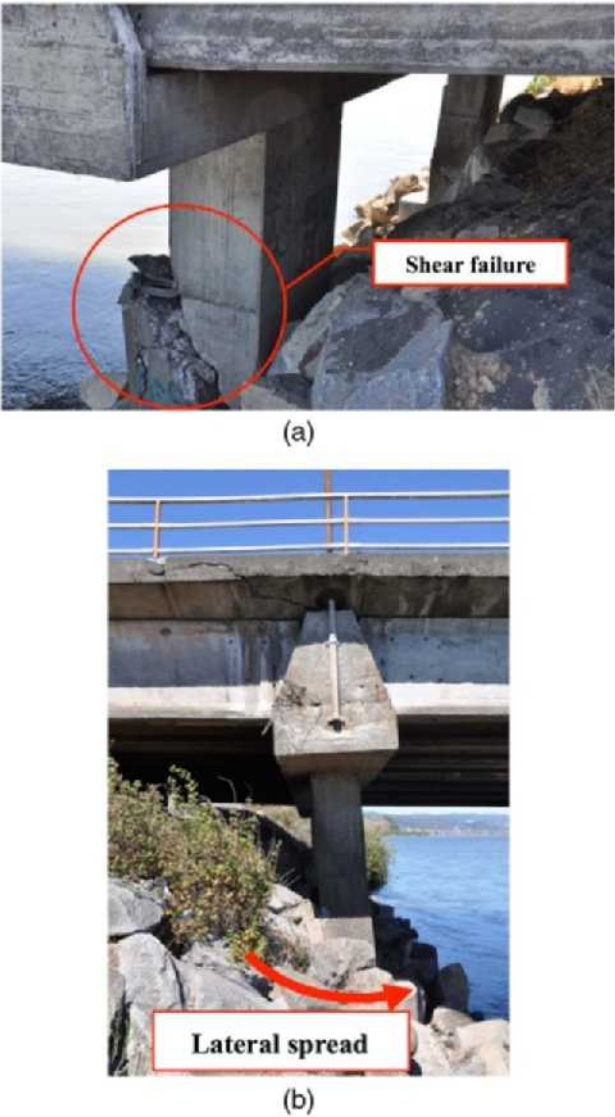
Column shear failure, vertical displacements of the bridge deck of up to 1 m, and rotation of the bridge bent of 1° to 3° occurred at the northeast approach. Figure 10 shows the shear failure of the column facing the bent's south side. The north column, also shown in Figure 10,

Figure 10. Juan Pablo II Bridge northeast approach: (a) Column shear failure, looking west, S36.816233° W73.084144°; and (b) rotation and lateral displacement of bridge bent, looking east, S36.816233° W73.084144°.

exhibited tension cracks and rotation as well as shear failure. In contrast with the damage observed at the northeast approach, the southwest approach suffered minor damage. This may be due to a combination of different soils conditions and more gentle slopes observed at the southwest approach.

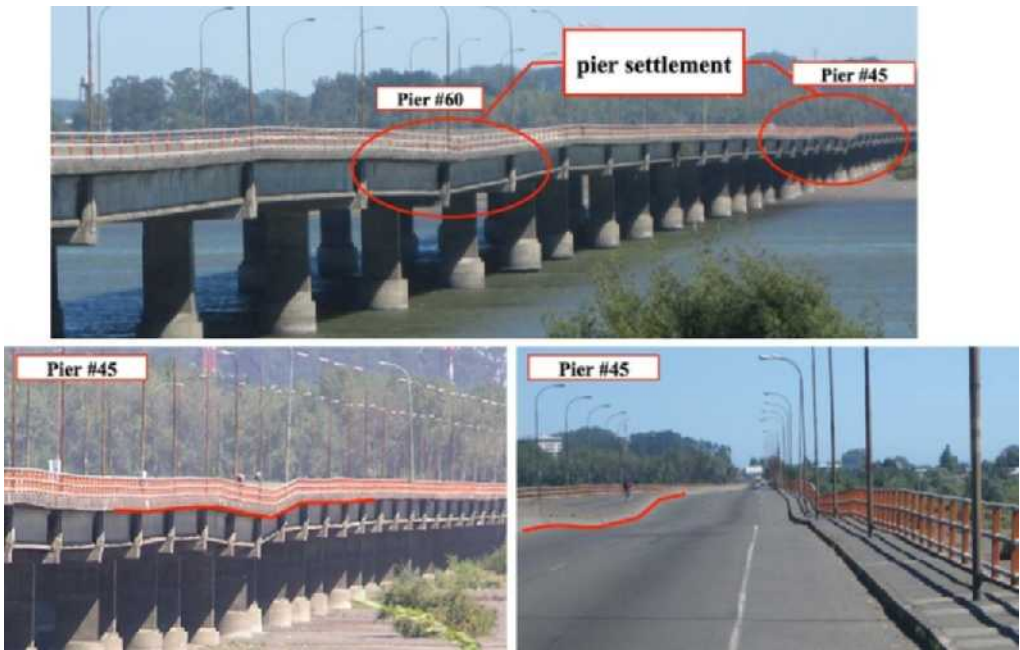
Pier settlements of 0.4 m to 1.5 m were observed at several locations along the length of the bridge (Figure 11). Vertical settlements appeared to be due to liquefaction of the soil near the pier foundations. Short pier foundation depths on the order of 16 m (in contrast to 22 m for the Llacolén Bridge) may also have contributed to these settlements. Visual inspection of the surrounding soils indicated the presence of loose sands near the surface. Although the Bío-Bío River was once navigable by ship up to the City of Nacimiento, over-logging during the twentieth century led to heavy erosion, choking the river with silt, and rendering it impassable to ship traffic. Near Concepción, the river behaves as a meandering river with fine-grained material deposited on the floodplains.

Settlements on the order of 0.6 m to 0.8 m were observed in piers #45 and #60, as indicated in Figures 11 and 12. The bridge deck accommodated these settlements with large vertical deformations, however relatively minor damage of the asphaltic layer was observed. As Figure 12 shows, settlements of piers #45 and #65 were larger on the upstream side, indicating rotation of these bents about the longitudinal axis of the bridge. This is consistent with the observations made by FHWA (2011): "... the spans of the main bridge also appeared to have experienced uneven support settlement, which tilted the columns and rotated the bridge deck about the centerline of the bridge." Soil in the vicinity of the

Figure 11. Juan Pablo II Bridge. Pier settlements (Pier #0 corresponds to San Pedro end).

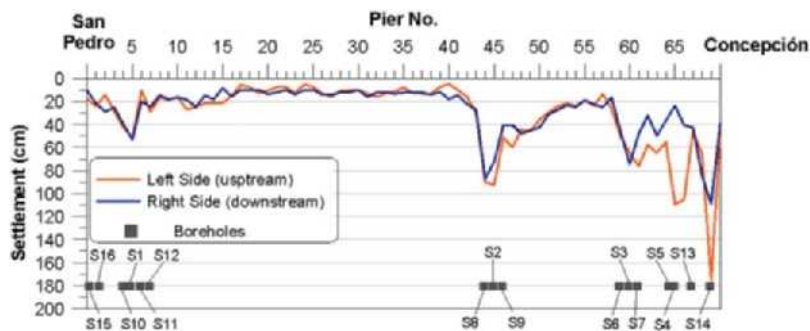
Figure 12. Juan Pablo II Bridge. Pier settlements and boring locations (Verdugo and Peters 2010).

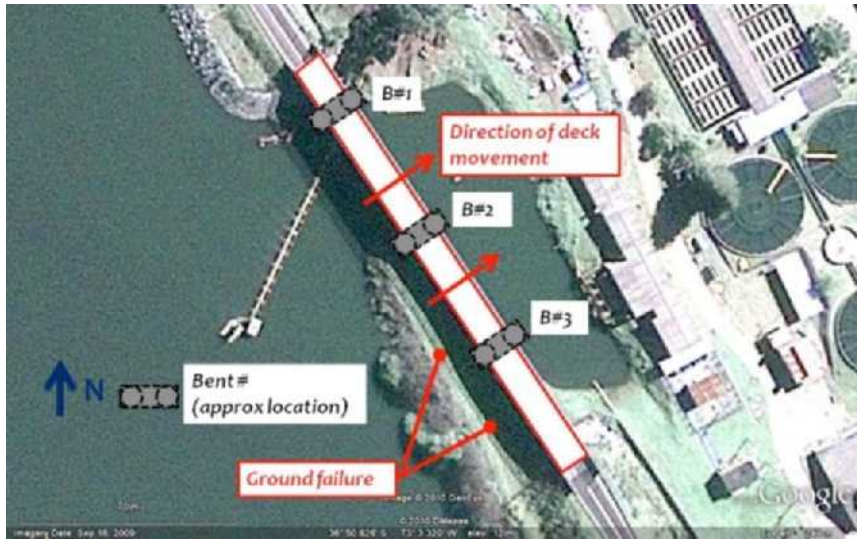
The La Mochita Bridge, shown in Figure 14, is a four-span (15, 50, 50, and 35 m spans) concrete bridge supported by seat-type abutments at each end and two-column bents at the interior locations. At this site, ground failure occurred along the NW–SE trending spit inducing transverse movement of the bridge superstructure. The transverse nature of ground failure observed at this bridge is unique compared to other failures observed elsewhere in Concepción and during past earthquakes, where lateral spreading or other ground failure typically causes bridge movement in the direction of the longitudinal axis of the bridge.

Figure 14. Plan view of the La Mochita Bridge in south Concepción describing observed damage (S36.846841° W73.055496°).

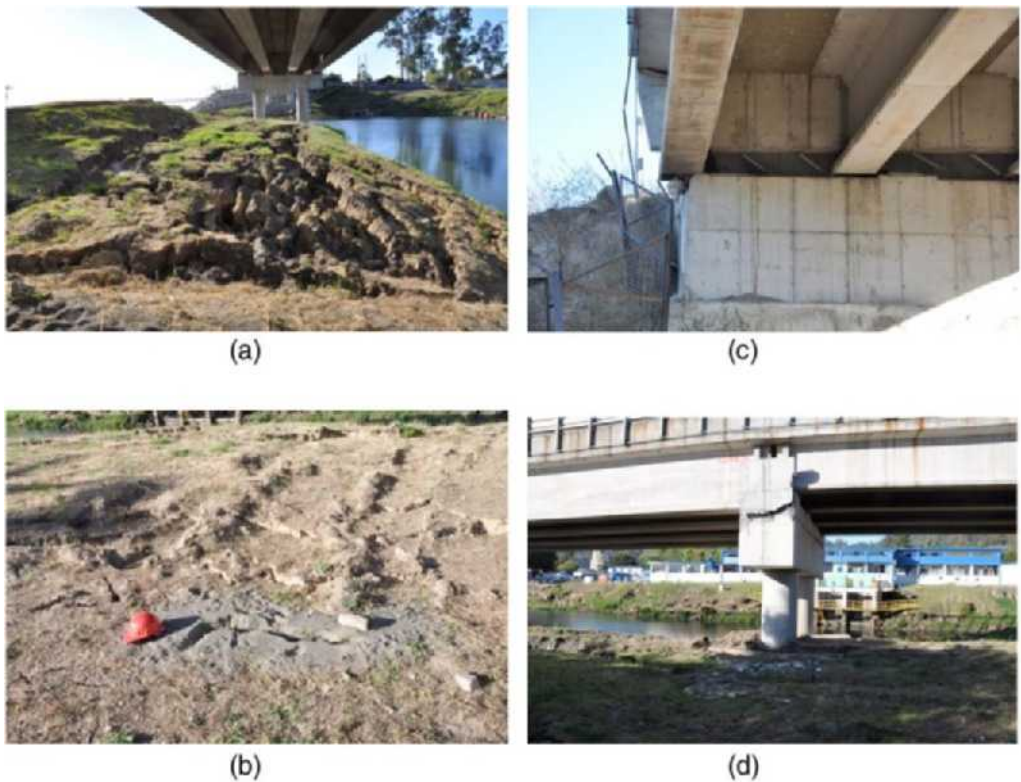
The bridge superstructure shifted transversely, largely as a unit, toward the east due to failure of the soil spit (Figure 16a). This failure may be attributable to either a deep-seated slope instability or a liquefaction-induced lateral spreading mechanism. The SPT profiles from the original project (Figure 15) show that the deep-seated slope instability is a possible mechanism of failure (note how the SPT values drop at depths of 15 m to 20 m). However, sand boils below the bridge were observed near bents #2 and #3 (Figure 16b), and the transverse rotation, or vertical movement, of the bents was limited, which suggests that liquefaction-induced lateral spreading could have also played a role in the bridge failure.

Measurements taken by the team on 15 March 2010, indicated that the north end of the bridge deck shifted 0.5 m to the east relative to the approach fill, while the south end of the bridge shifted 0.9 m toward the east relative to the approach fill on that side. LIDAR measurements show that these lateral displacements were, respectively, 0.3 m and 0.8 m (Kayen 2012). Bents #2 and #3 subassemblies (columns, bent cap, and pile cap) were observed to rotate slightly about the longitudinal axis of the bridge toward the east consistent with the deck movement. Rotations of bents #2 and #3 were measured as 2° and 4°, respectively. Bent #1 could not be accessed at the time of the teams' visit; however, views from the spit suggested that the deck moved independently of bent #1. Movement of the abutments was observed to be minimal, with the resulting damage to the superstructure largely attributed to the translation of the bents (Figure 16c). FHWA (2011) indicates that fill settlement at the abutments varied from 0.3 m to 0.8 m, and that the piers moved laterally about 0.1 m to 0.15 m, and vertically about 0.05 m to 0.1 m. It is noted that movement of the bridge, either shaking- or kinematically-induced, resulted in damage to both east and west end transverse shear keys of the interior bents (Figure 16d).

Figure 16. Liquefaction-induced damage at La Mochita bridge: (a) Looking north at bent #3, S36.847389° W73.055219°; (b) sand boils observed below the bridge, S36.847456° W73.055129°; (c) transverse shift of deck relative to south abutment, S36.847547° W73.054876°; and (d) damage to transverse shear key at bent #3, S36.847405° W73.055084°.

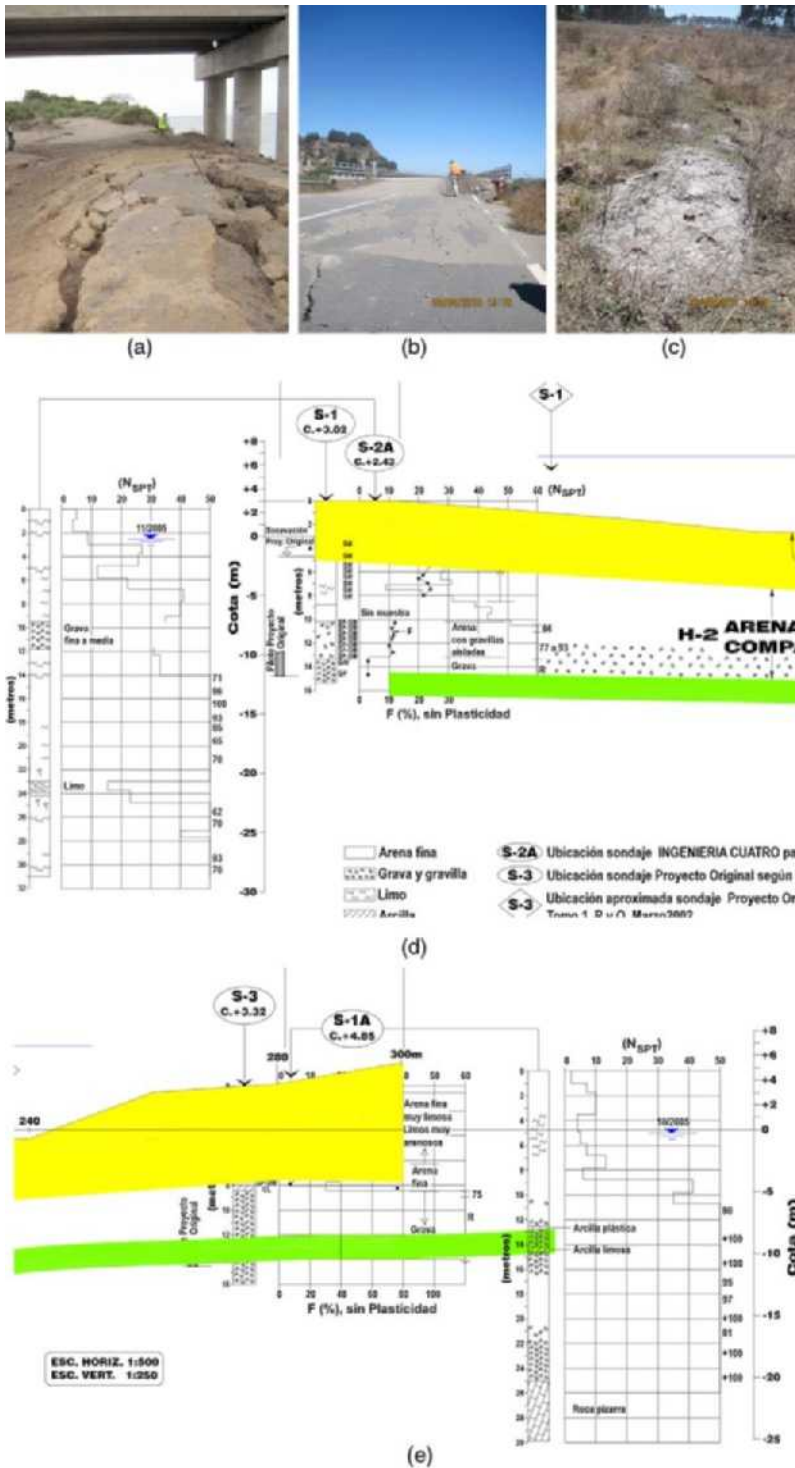
Figure 17. Mataquito bridge: (a) Lateral spreading on the south end of the bridge, S35.050712° W72.162258°; (b) approach fill settlement at the north abutment of the bridge (70 cm offset at the bridge deck), S35.050712° W72.162258°; (c) sand boils at the north end, S35.051961° W72.163217°; (d) SPT profiles at the Iloca (north) abutment; and (e) SPT profiles at the Quivolgo (south) abutment. Colors in (d) and (e) represent different soil units. SPT profiles obtained before the earthquake.

Soil conditions at the north (Iloca) abutment consist of 5 m of liquefiable fine sand with SPT values ranging from 5 to 20 blows/foot, underlain by a layer of fine compact sand 9 m thick, which in turn is underlain by sandy gravel (Figure 17d). Soil conditions at the south (Qui-volgo) abutment consist of 9 m of liquefiable fine sand with SPT values below 10 blows/foot, underlain by a layer of fine compact sand 4 m thick, which in turn is underlain by sandy gravel (Figure 17e).

Lateral spreading on the south abutment appeared to be more confined, probably due to a combination of the topography of the area and the “pile-pinning” effect. In contrast, on the north side, and due to the large extent of the fields that surround the bridge, moderate to significant lateral spreading was observed extending landward 270 m from the river edge. Lateral spreading from the edge of the abutment wall to the first row of piers was about 54 cm and the total lateral spreading from the edge of the abutment wall to the river’s edge was about 180 cm (over a distance of about 65 m). The approach embankment is about 7.6 m high, and settled about 70 cm relative to the bridge deck. The approach embankment experienced a transverse movement of about 60 cm from the centerline as manifested by cracking of the asphalt over a distance of about 200 m. The locally heaved ground, observed at the toe of the embankment, indicates soil crust compression, likely as a result of liquefaction of the underlying soil. A bridge girder was partially sheared at the first pier on the north side. The bridge remained in use after the earthquake.

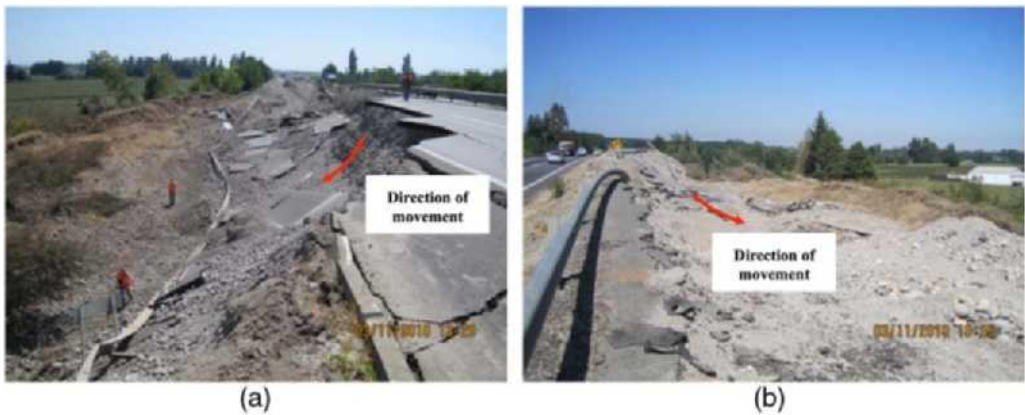
Two collapsed embankment fills were identified near Copihue and Parral. The first, shown in Figure 18, occurred along a straight section of Ruta 5 located approximately 8 km north of Parral. The southbound lanes collapsed to the west, apparently as a result of a shallow translational slide in near-surface foundation soils (~ lateral spreading), as evidenced by the failed soil mass location and a mound of soil pushed up at the west toe of the embankment (Figure 18a). The embankment failed along a length of approximately 150 m at a location where a low-lying softer soil was located at the toe. No geotechnical information could be found for this specific location. However, the soil conditions nearby consist of about 4 m of sandy silt and silty clay (SPT values below 20 blows/foot) underlain by cemented sandy silt, locally known as “tosca.” Geotechnical information found for this area shows that the location of the phreatic surface varies seasonally from 1 m to 9 m deep (Figure 19).

Figure 18. Embankment fill collapsed near Copihue, north of Parral, closing the southbound lanes of Ruta 5: (a) view from the south, (b) view from the north, S36.087891° W71.791513°.

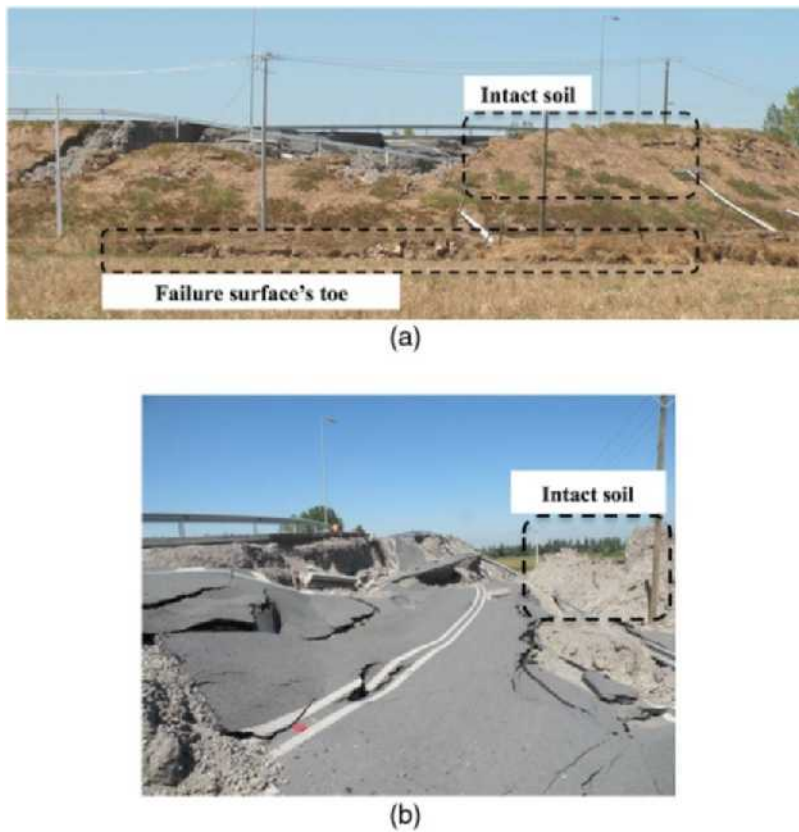
The second failure (Figure 20) occurred on an overpass of Ruta 5 located approximately 13 km north of Parral. The overpass embankment was curved and the embankment failed

Figure 20. Curved overpass embankment failure 13 km North of Parral: (a) Translational 3D slide failure, $S36.0343^\circ$ $W71.7568^\circ$; and (b) failed outside of the curved embankment, $S36.0347^\circ$ $W71.7558^\circ$.

over a length of about 80 m toward the outside of the curved section. Again, the failure appeared to involve a shallow translational slide in the near surface foundation soils, as evidenced by the intact failed soil mass and the mound of soil pushed up at the toe (Figure 20). Three-dimensional effects potentially contributed to failure to the outside of the curved embankment section as opposed to the inside of the embankment. As Figure 20 shows, a portion of the outside section of the slide mass displaced laterally about 6 m (Kayen 2012), and it remained completely intact.

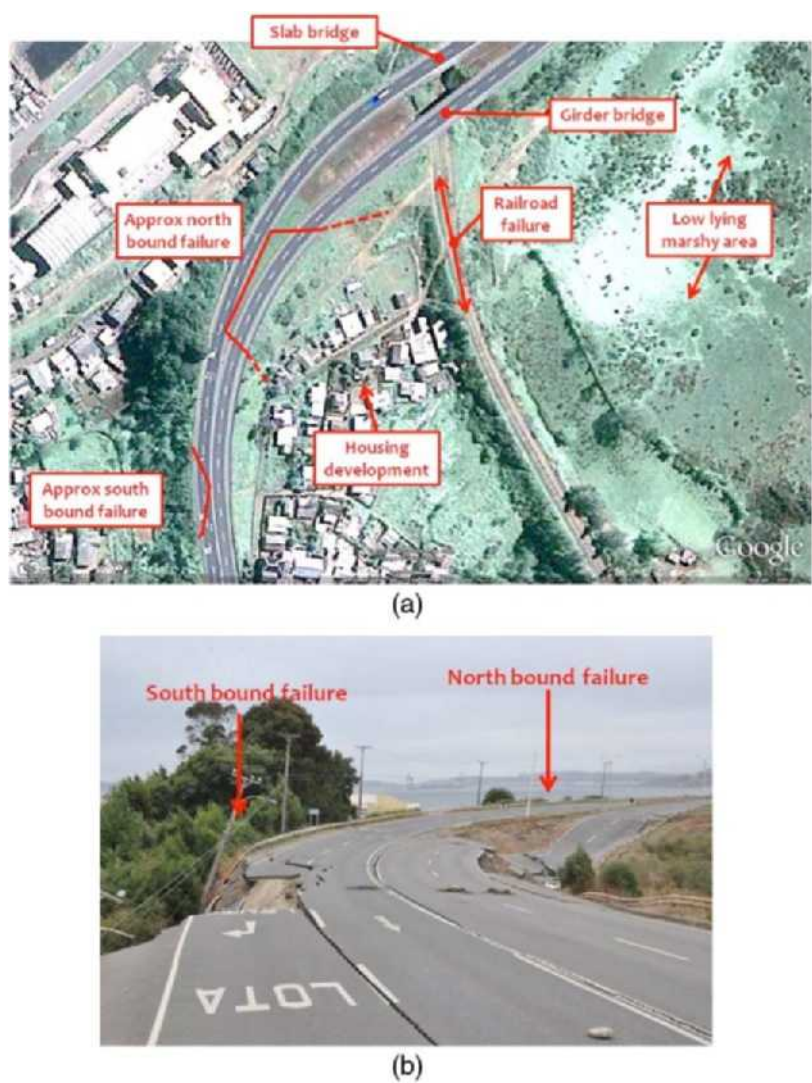
Several large ground failure areas were observed north of Lota along Route 160. Two failures resulted in damage to a roadway embankment section (denoted herein as the “southbound failure” and “northbound failure” in Figures 21 and 22, respectively), while a third failure resulted in damage to an elevated railroad section (denoted as “railroad failure” and discussed in the subsequent section). Minor side road spreading failures were also observed

Figure 21. (a) Plan view of approximate affected area, S37.0734° W73.1469°; and (b) view looking north on Route 160 showing south bound and north bound failure areas, S37.0744° W73.1480°.

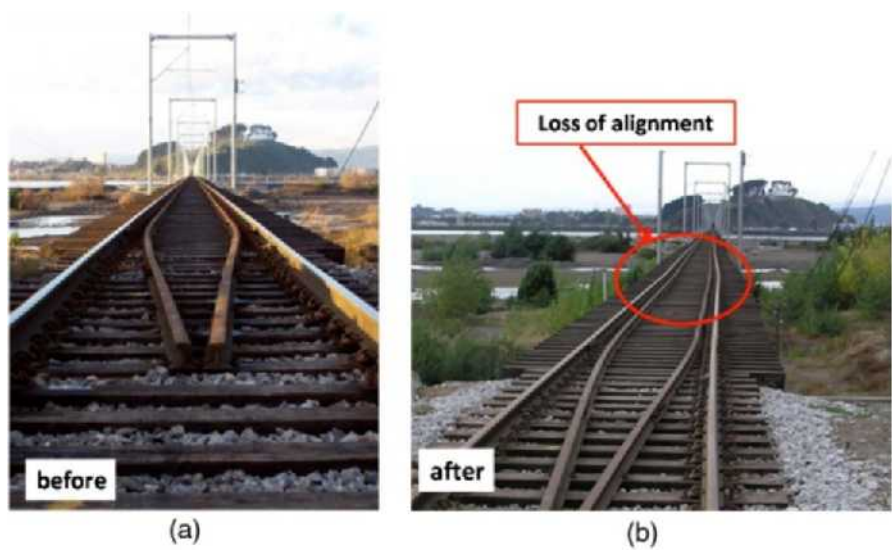
Figure 23. (a) Rails aligned before earthquake and (b) rails bent after earthquake, S36.836097° W73.087094°.

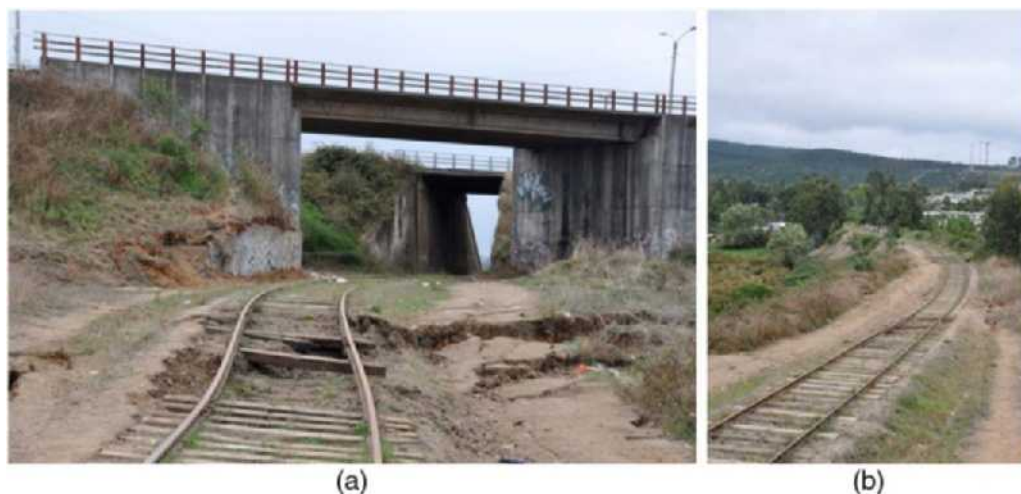
The bridge overcrossings, and therefore the road embankments, of the north- and southbound sections of Highway 160 north of Lota may have been constructed at different times, as evidenced by differences in construction type of the bridges (Figure 25a; also, see

Figure 21a, denoted as slab and girder bridges). The neighboring elevated railroad failure is characterized as a slump with lateral spreading, likely due to settlement of the compacted fill (Figure 25a). The railroad was approximately 5 m to 7 m above the low-lying marshy area along the section that failed.

Figure 25. (a) Slab and girder-type overpasses at northern end of road embankment failure area, showing railroad and supporting ground settlement (view looking west), S37.0729° W73.1469°; and (b) ground failure below elevated railroad east of road embankment failure (view looking east), S37.0727° W73.1471°.
